Incitec Pivot

When a major company's production of fertiliser was disrupted due to an adverse chemical reaction resulting in 12 to 14 ton of fertiliser product setting hard within its vessel which also affected the production of other product lines, Incitec Pivot's Process Manager, Peter Maurer, contacted Super City Concrete Cutting to quickly resolve the problem.

Solving the Problem With a Hydraulic Splitting and Bursting System:

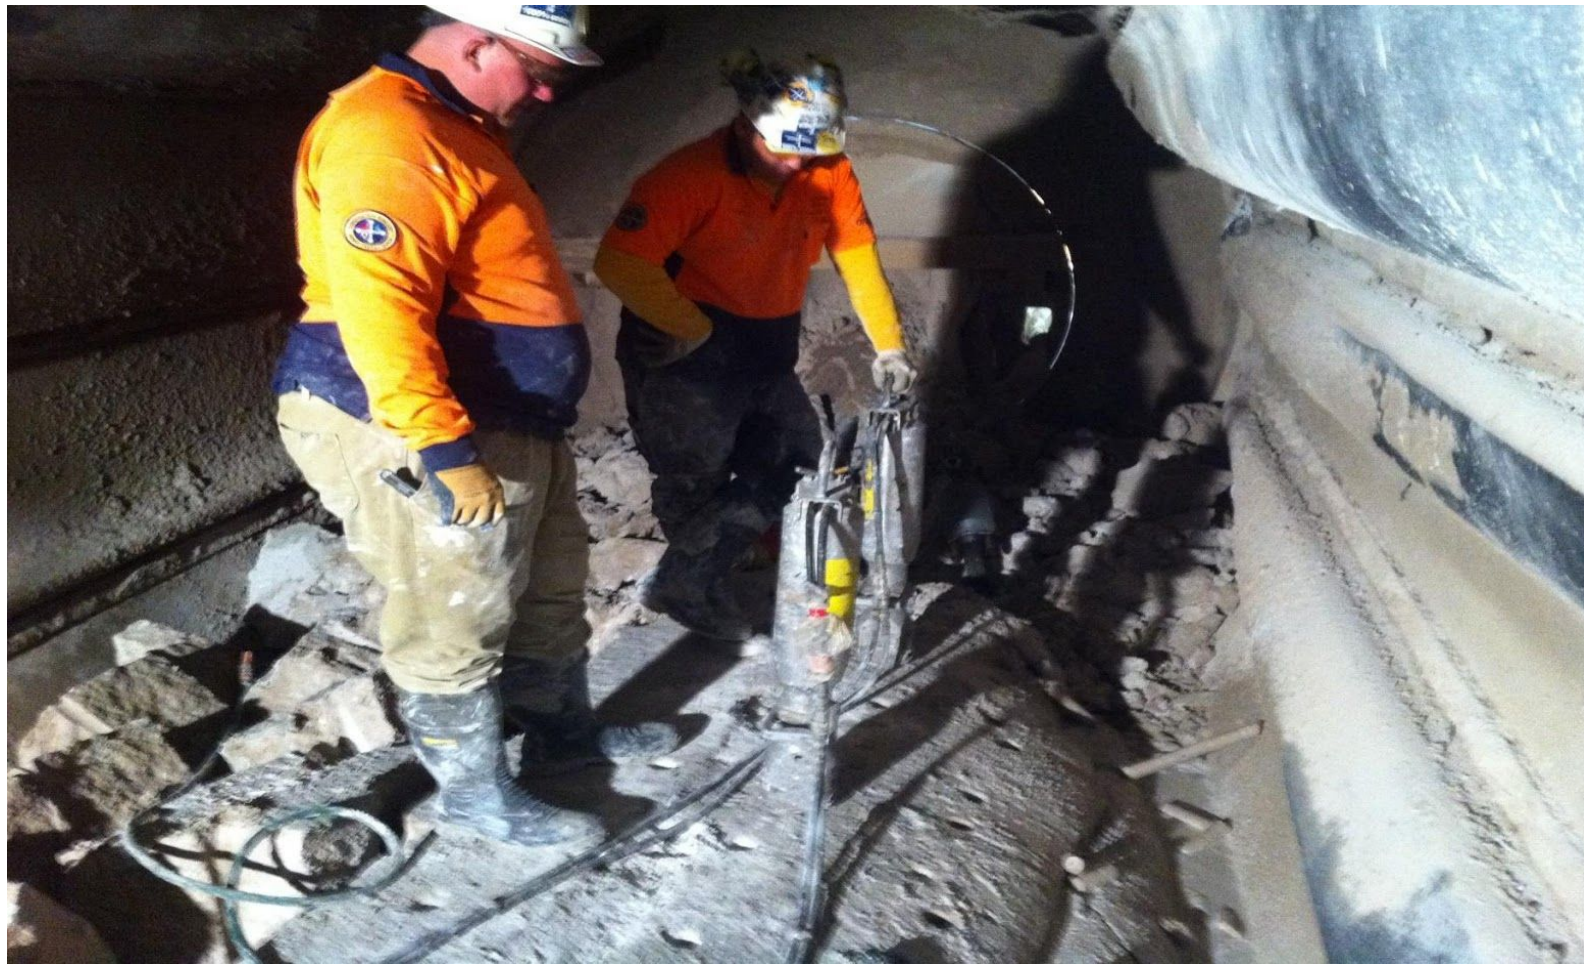
An adverse chemical reaction solidified 12-14 ton of fertiliser product within its vessel. While Incitec had a procedure in place to rectify the problem, it was proving very expensive and time consuming.

Once the trial line of holes was completed we inserted 2 x C9 darda splitters and applied the pressure to the system. The result was very pleasing as it cracked and opened up the material to the size and shape we had planned. We were then able to move and shift different areas of material using darda combi shears with a lifting rate of 6000kg.

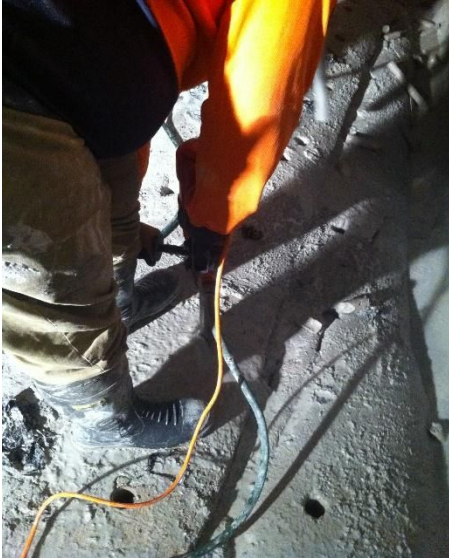
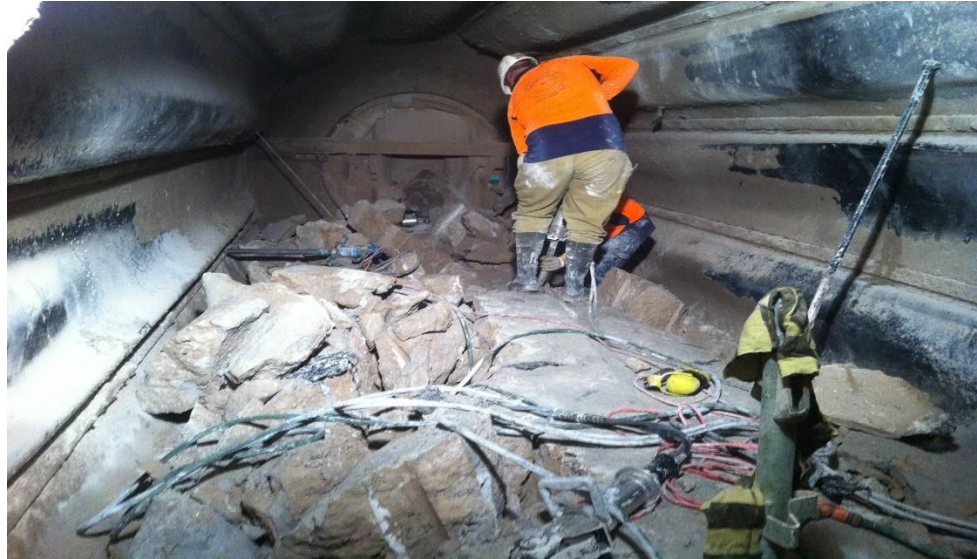
Essentially the major issues and safety concerns were accessing the work area within the processing dryer. The dryer is a horizontal cylindrical vessel 8m long with a diameter of 2.5m. Access into the dryer vessel is limited to a single entry inspection door 700mm wide x 1600mm high. breaking the hardened material into large chunks for manual removal

breaking up the materialThe majority of the mass section of material had been cracked through the expandable grout process. This meant that regardless of the hole patterns we were trying to create the effect of the darda systems would always follow the cracks created by the expandable grout.

There was not enough room in the confined space to operate our equipment safely and extract the material at the same time. work shifts were required to remove the material safely
