When a major company's production of fertiliser was disrupted due to an adverse chemical reaction resulting in 12 to 14 ton of fertiliser product setting hard within its vessel which also affected the production of other product lines, Incitec Pivot's Process Manager, Peter Maurer, contacted Super City Concrete Cutting to quickly resolve the problem.

Solving the Problem With a Hydraulic Splitting and Bursting System:

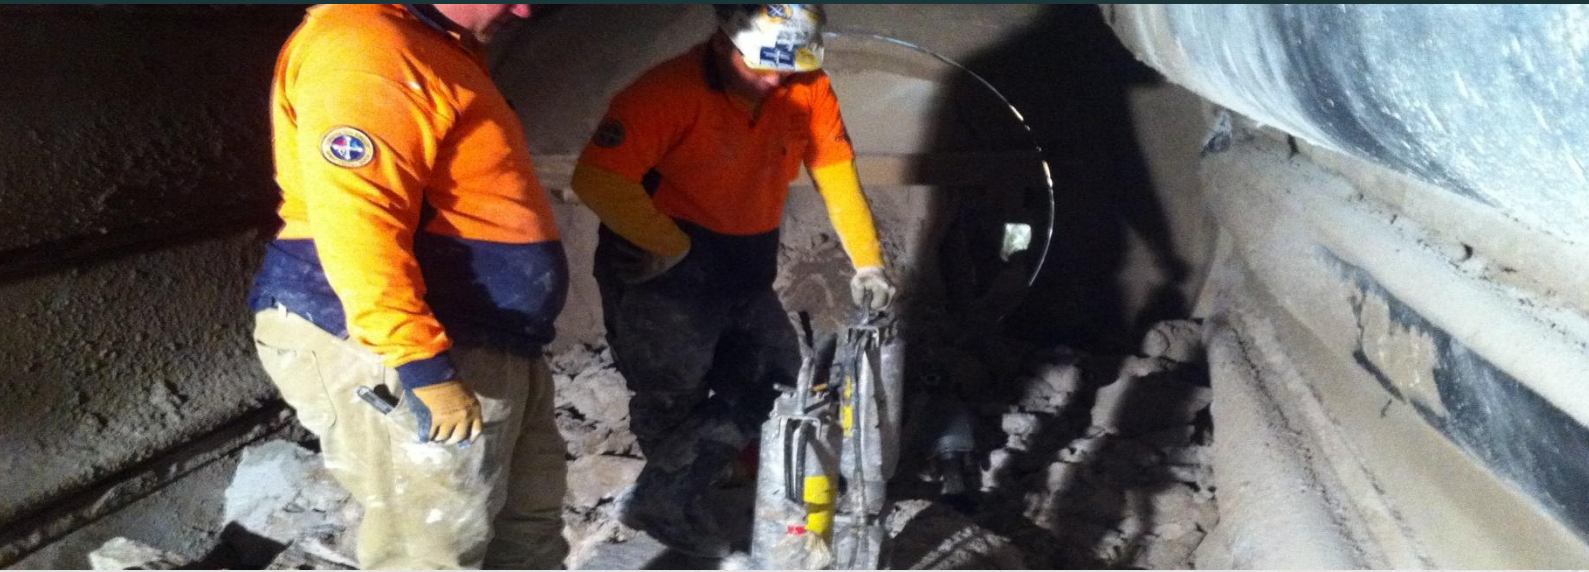
Essentially the major issues and safety concerns were accessing the work area within the processing dryer. The dryer is a horizontal cylindrical vessel 8m long with a diameter of 2.5m. Access into the dryer vessel is limited to a single entry inspection door 700mm wide x 1600mm high. breaking the hardened material into large chunks for manual removal

Once the trial line of holes was completed we inserted 2 x C9 darda splitters and applied the pressure to the system. The result was very pleasing as it cracked and opened up the material to the size and shape we had planned. We were then able to move and shift different areas of material using dardacombi shears with a lifting rate of 6000kg.

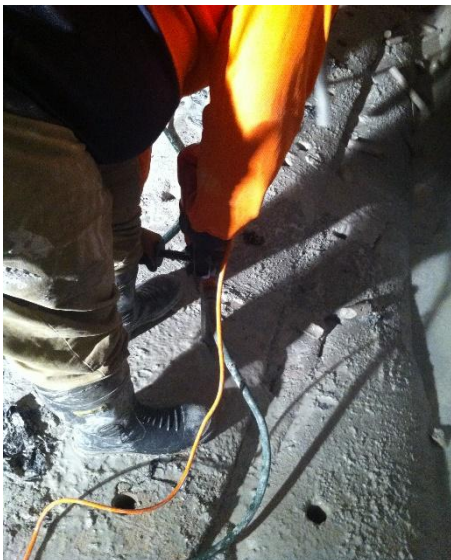
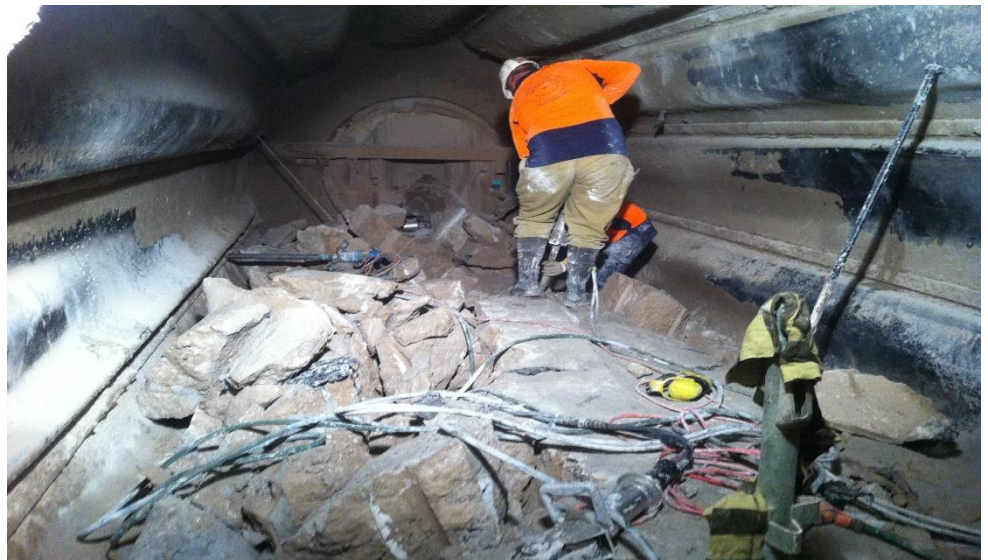
breaking up the material The majority of the mass section of material had been cracked through the expandable grout process. This meant that regardless of the hole patterns we were trying to create the effect of the darda systems would always follow the cracks created by the expandable grout.

There was not enough room in the confined space to operate our equipment safely and extract the material at the same time. work shifts were required to remove the material safely
