St John of God Hospital

Contract Type: Controlled demolition using diamond wire saw, track saw, floor saw to remove 4 levels of building landings, façade and staircases for new extension works. St John of God Hospital, Geelong, Victoria

Silent Demolition:

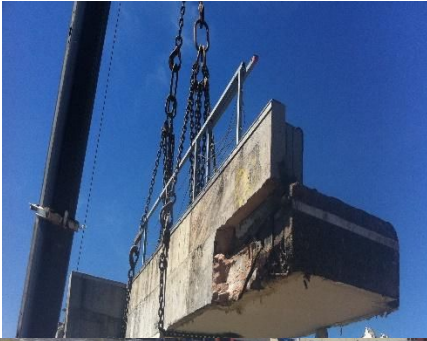
Level 3, corner of building, including stairwell and landing area, 15000kg lift Jason agrees. "Hospital environments create a number of challenging considerations that we had to consider when pricing and planning the various stages of work."

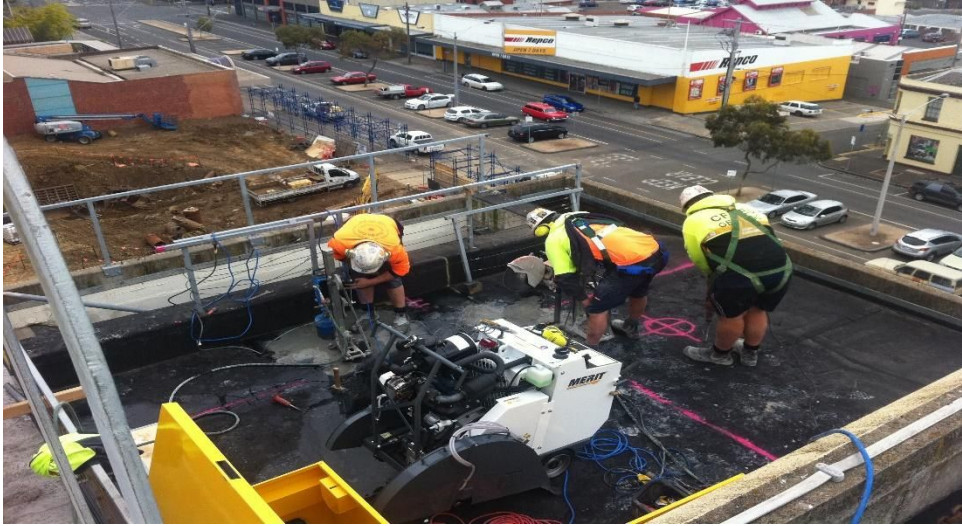
Support columns were cut using diamond wire saws with 1no lift hole core drilled through the beam's centre for support. Internal staircases and wall panels were cut using an electric track saw with 2no 175mm core holes in each section for rigging access. Setting up for vertical cut with 1600mm diameter blade
