Contract Type: Controlled demolition using diamond wire saw, track saw, floor saw to remove 4 levels of building landings, façade and staircases for new extension works. St John of God Hospital, Geelong, Victoria

Silent Demolition:

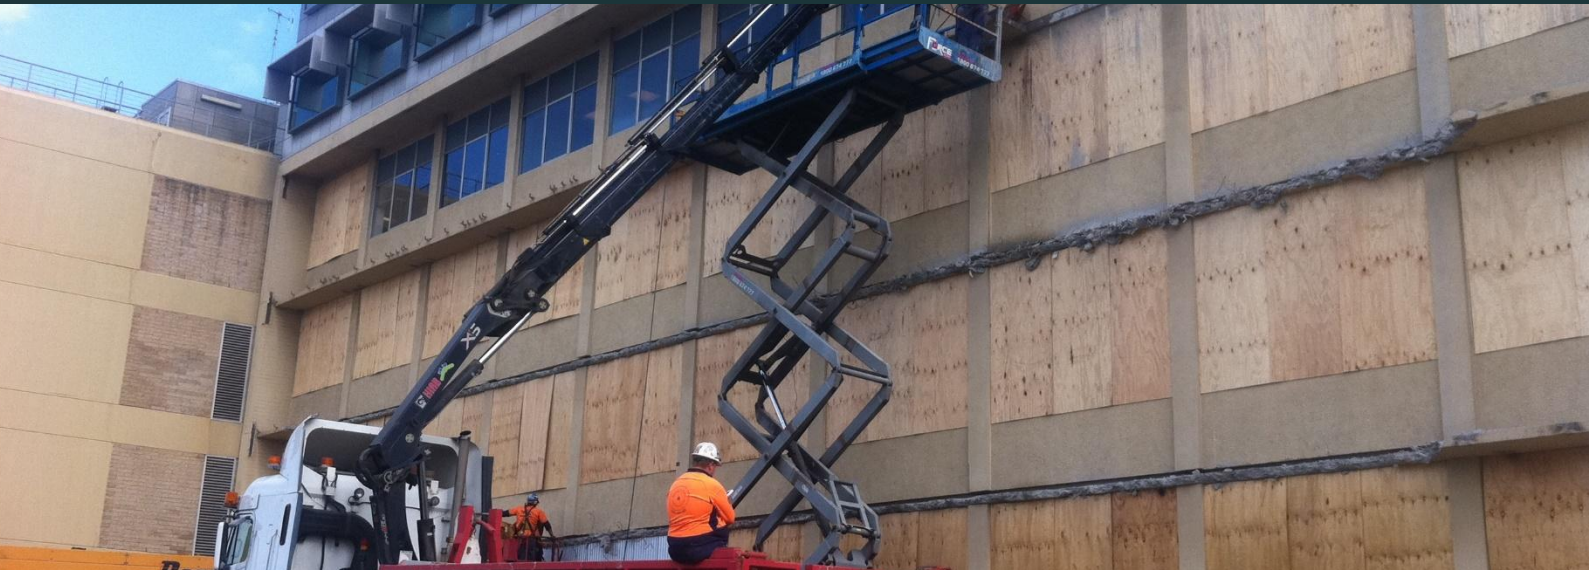
1st lift Level 4, 12000kg concrete section cut with diamond wire saw and floor saw. While usually straight-forward work involving traditional jackhammering and breaking methods, the excessive vibration and noise would have severely impacted four adjacent levels of operating theatres and patient recovery wards. The demolition required a more controlled approach to the work. Compounding the project's risk and complexity were additional height factors and the irregular shape, size and excessive weight of sections needing removal.

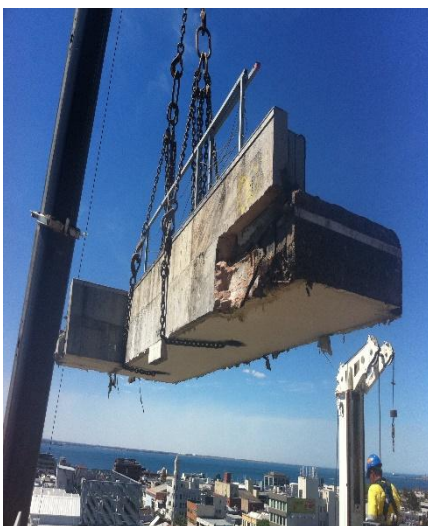
Level 3, corner of building, including stairwell and landing area, 15000kg lift Jason agrees. "Hospital environments create a number of challenging considerations that we had to consider when pricing and planning the various stages of work."
